Manhole Inspection Summary

Manhole # S49EE_018MH

Inspection ☐ Is Incomplete Rating: **3) Fair**

Location Address: **Luzerne**

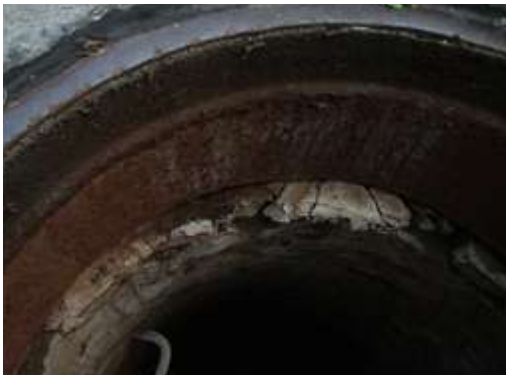
Defect 1

Condition: ☐ Sound ☐ Cracked ☐ Root Intrusion ☒ **Loose Brick** ☐ Deteriorated

Infiltration: ☐ None ☐ Joint ☐ Cracks ☒ **Mortar** ☐ Roots ☐ Wall

loose brick

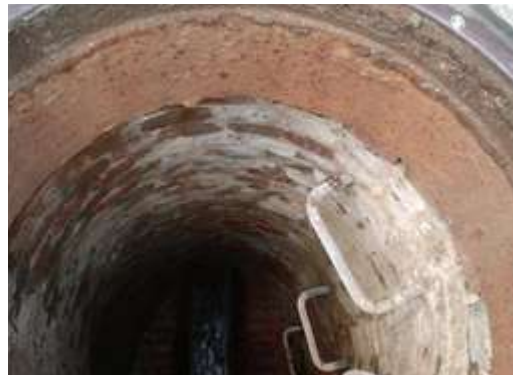
Defect 2

frame leaks

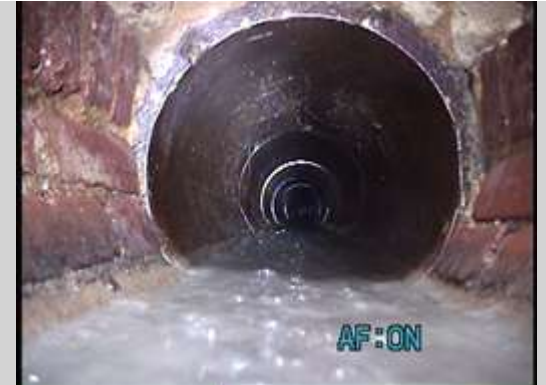
12 O'Clock Outflow

15 in. Circular Gravity Sewer
Pipe Out @ 12 O'Clock

Pipe Height: **15.6** (in.) Rod and Bar (Angled)
Pipe Material: **Clay** ☐ Pipe Lined
Invert Depth: **10.80** (ft.) Flow Characteristics: **Fast**
Deposits: ☒ None ☐ Mud ☐ Sludge ☐ Debris ☐ Grease
Silt Depth: (in.) Deposits Extent:
Infiltration: **None** Pipe Seal Cond: **Sound**

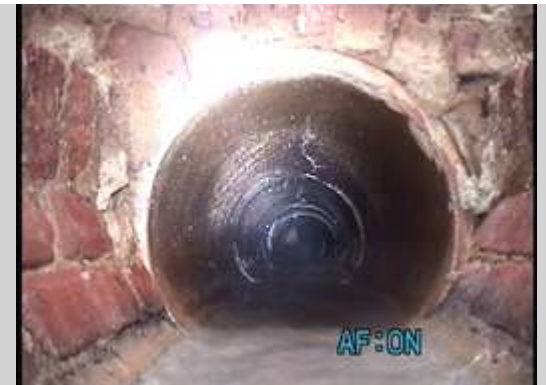
6 O'Clock Inflow

12 in. Circular Gravity Sewer
Pipe In @ 6 O'Clock

Pipe Height: **12** (in.) Rod and Bar (Angled)
Pipe Material: **Clay** ☐ Pipe Lined
Invert Depth: **10.70** (ft.) Flow Characteristics: **Fast**
Deposits: ☒ None ☐ Mud ☐ Sludge ☐ Debris ☐ Grease
Silt Depth: (in.) Deposits Extent:
Infiltration: **None** Pipe Seal Cond: **Sound**
